IDWR Managed Recharge Program

**Mile Post 31 and Lake Walcott
Recharge Sites**

September 2013

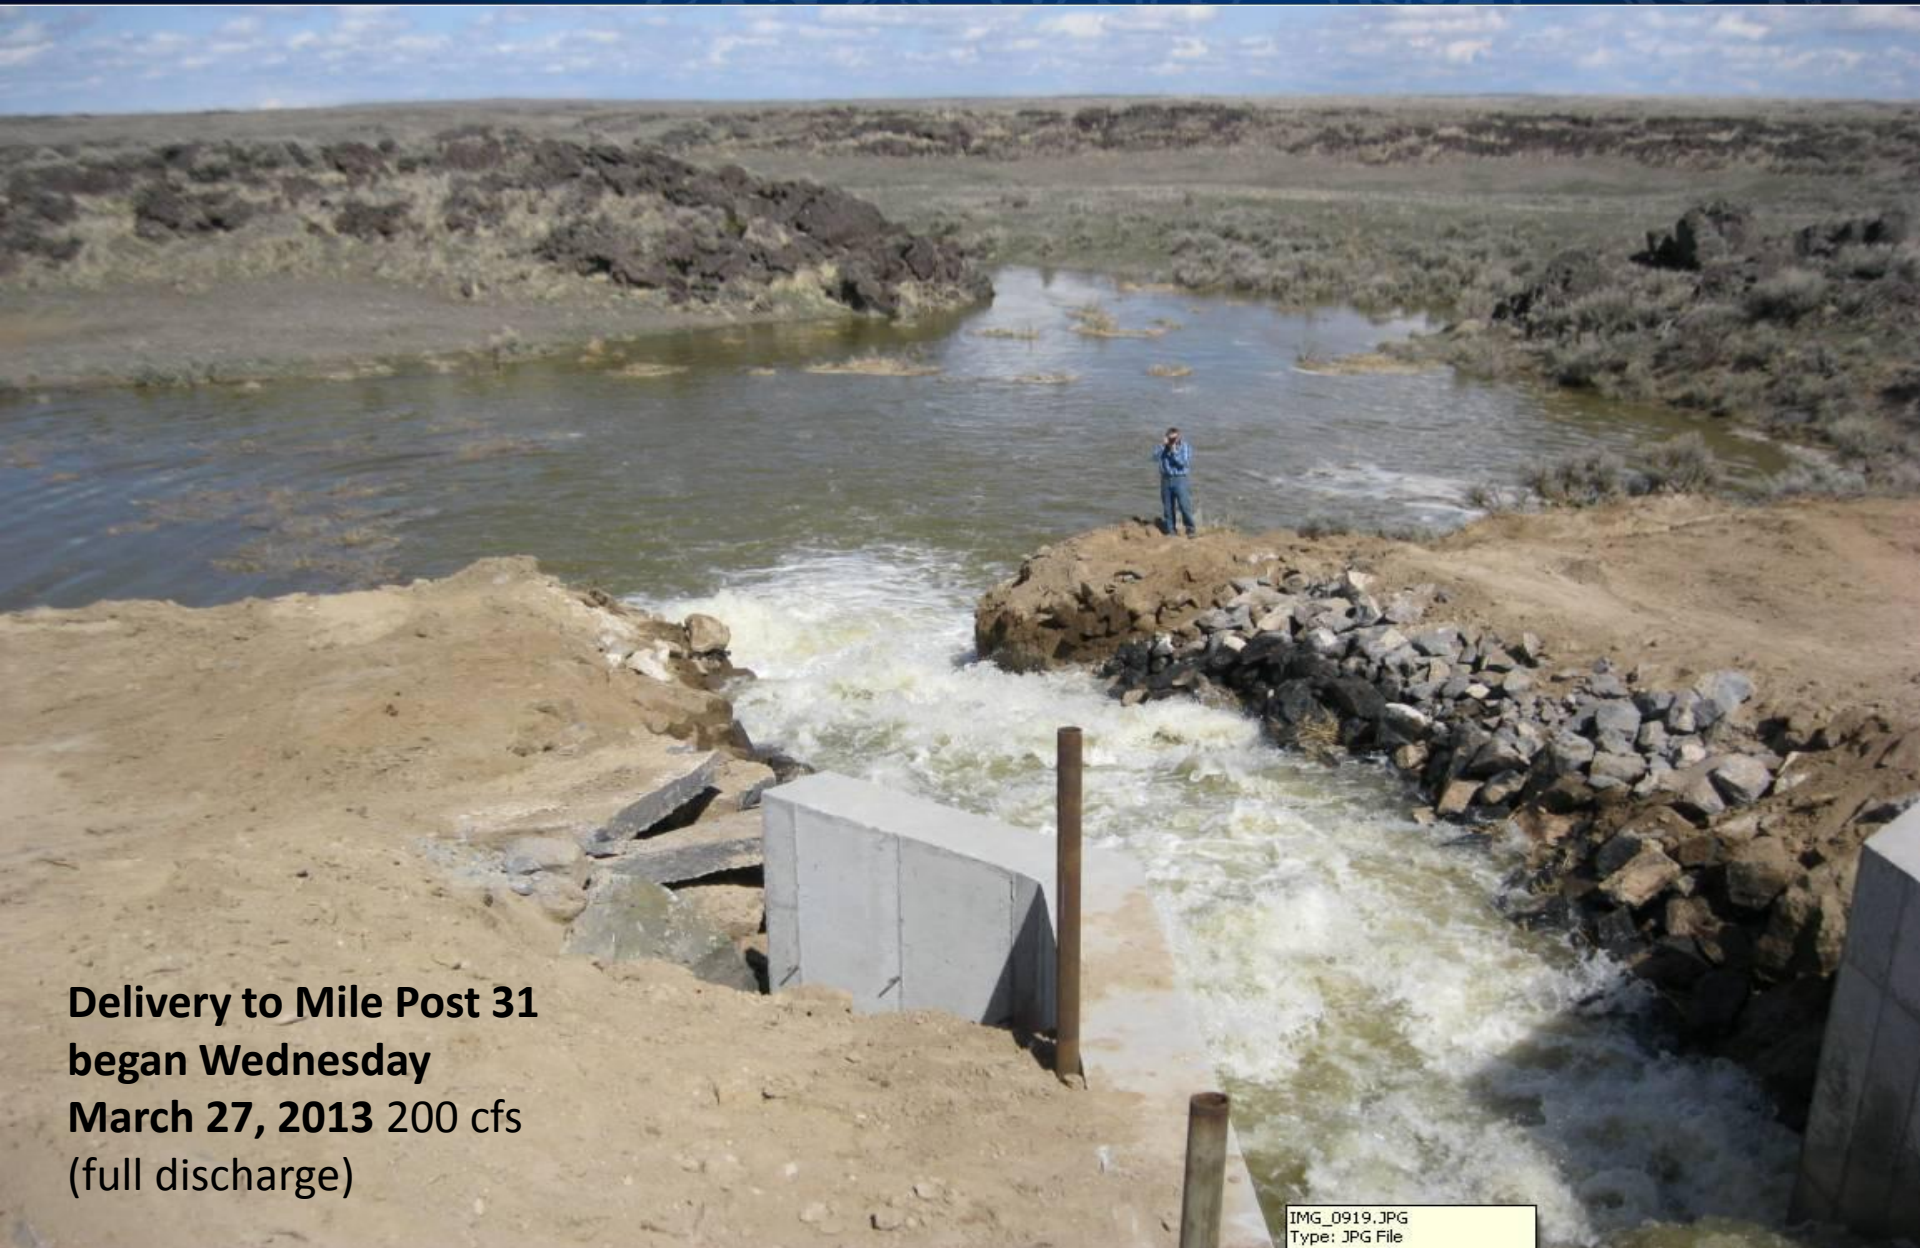
**Delivery to Mile Post 31
began Wednesday
March 27, 2013 200 cfs
(full discharge)**

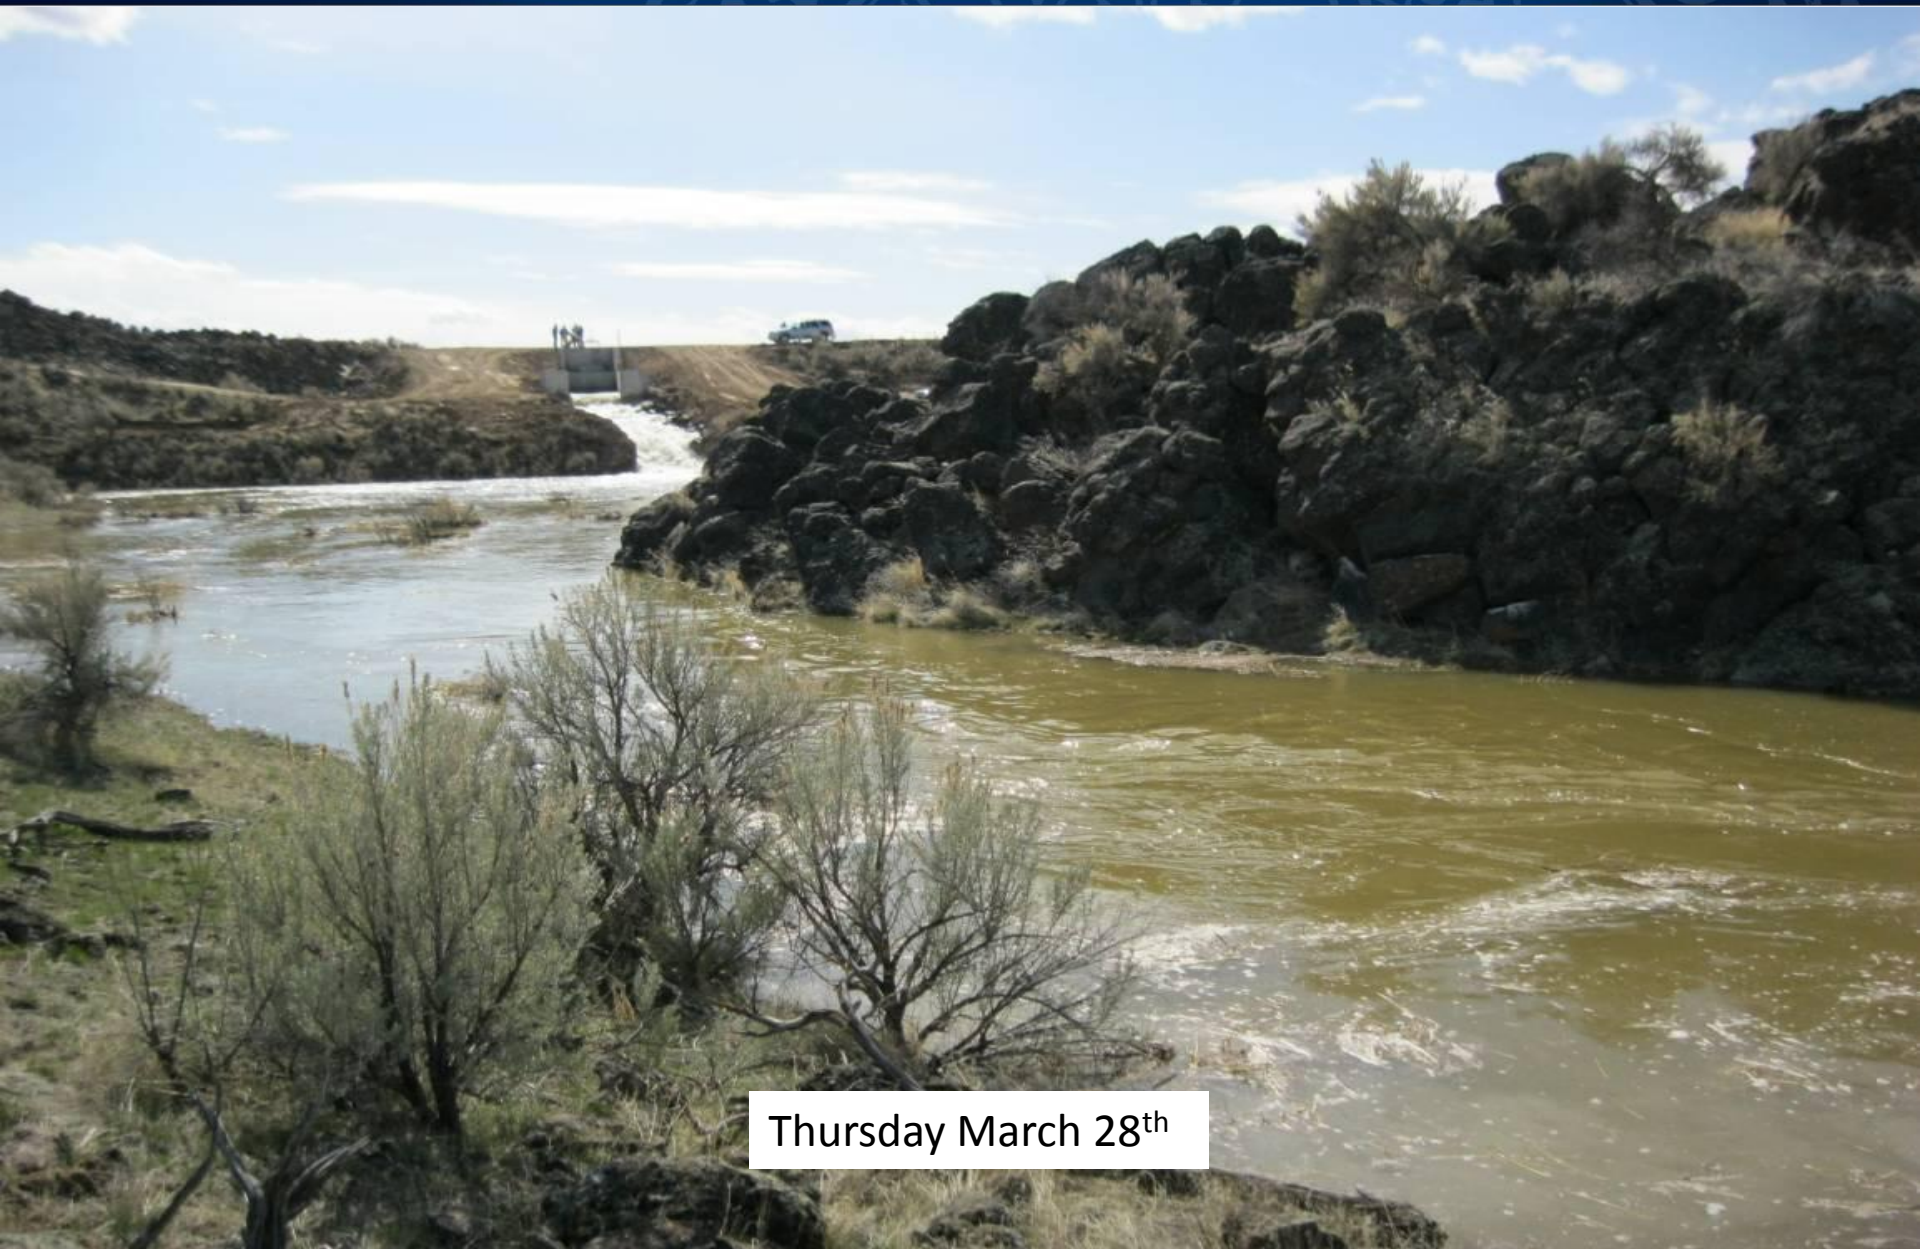
Thursday March 28th

Peak pool level
Friday March 29th
(Milner Gates shut down)

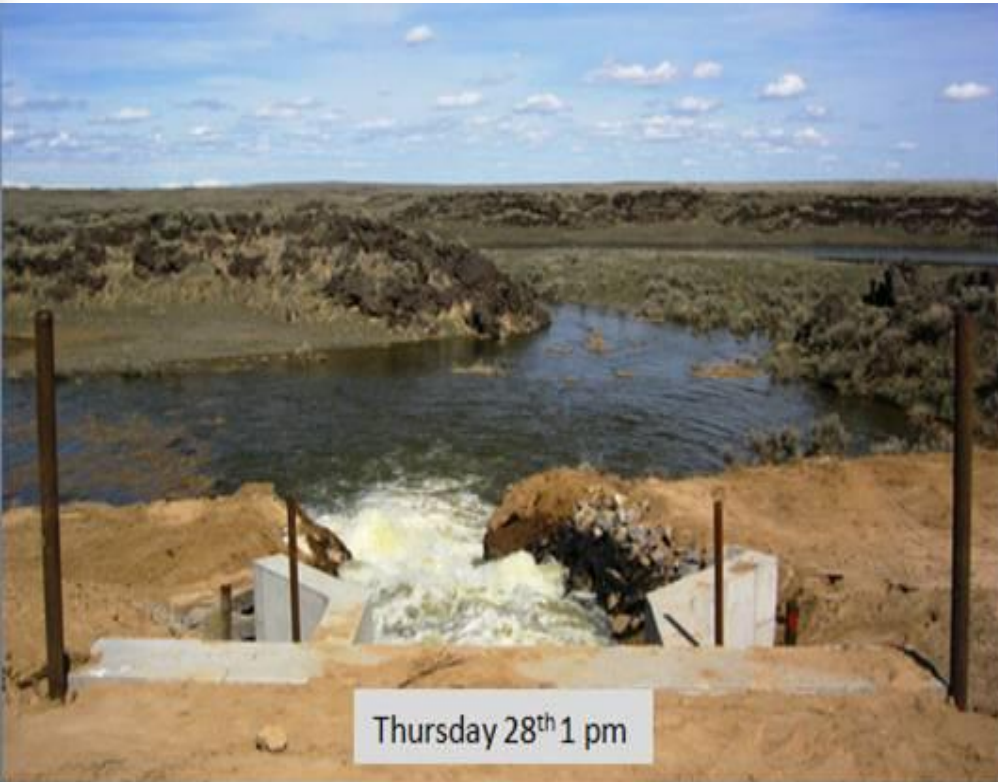
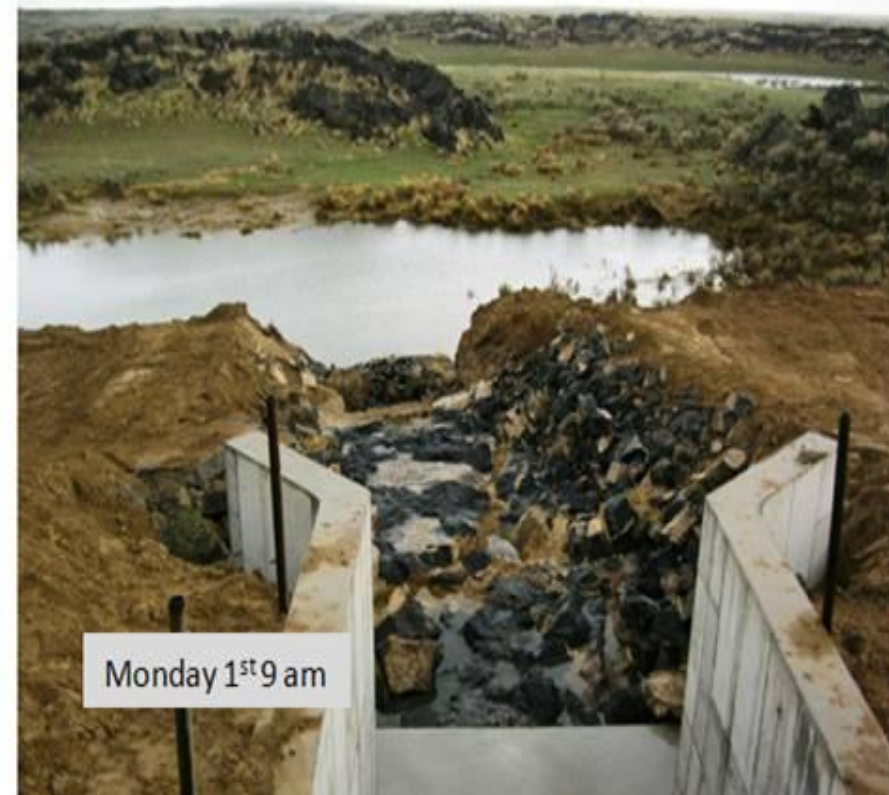
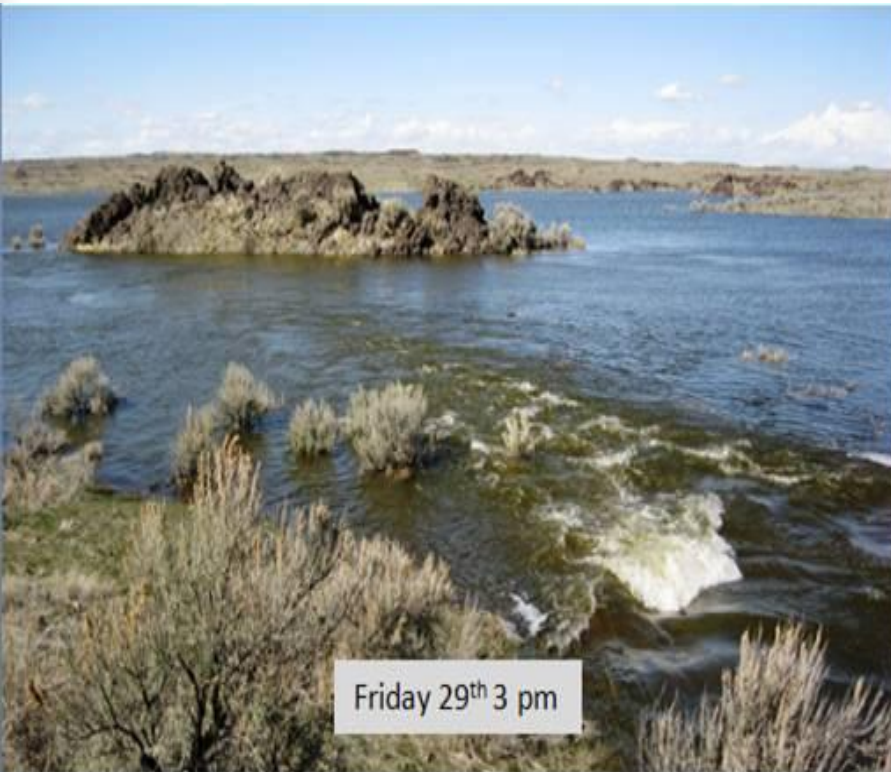
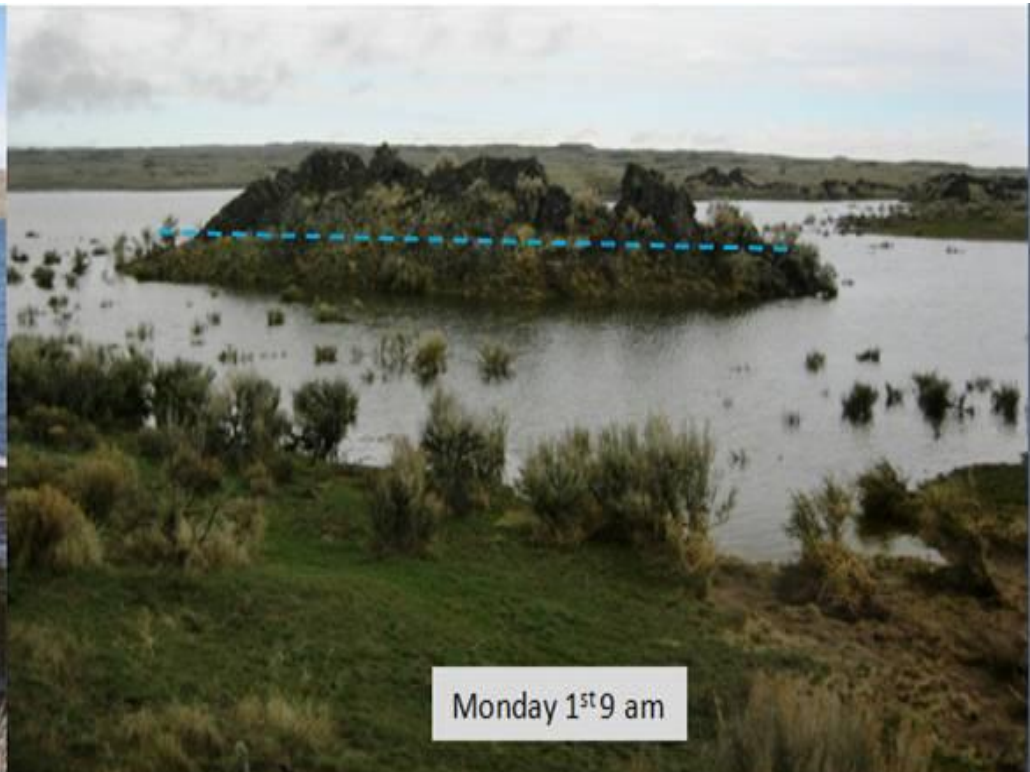
Pool at full level on Friday March 29th compared to Monday April 1st (draining).
Discharge into the site from the canal was completed midnight Saturday March 30th.
